The Decision to Launch the Space Shuttle Challenger

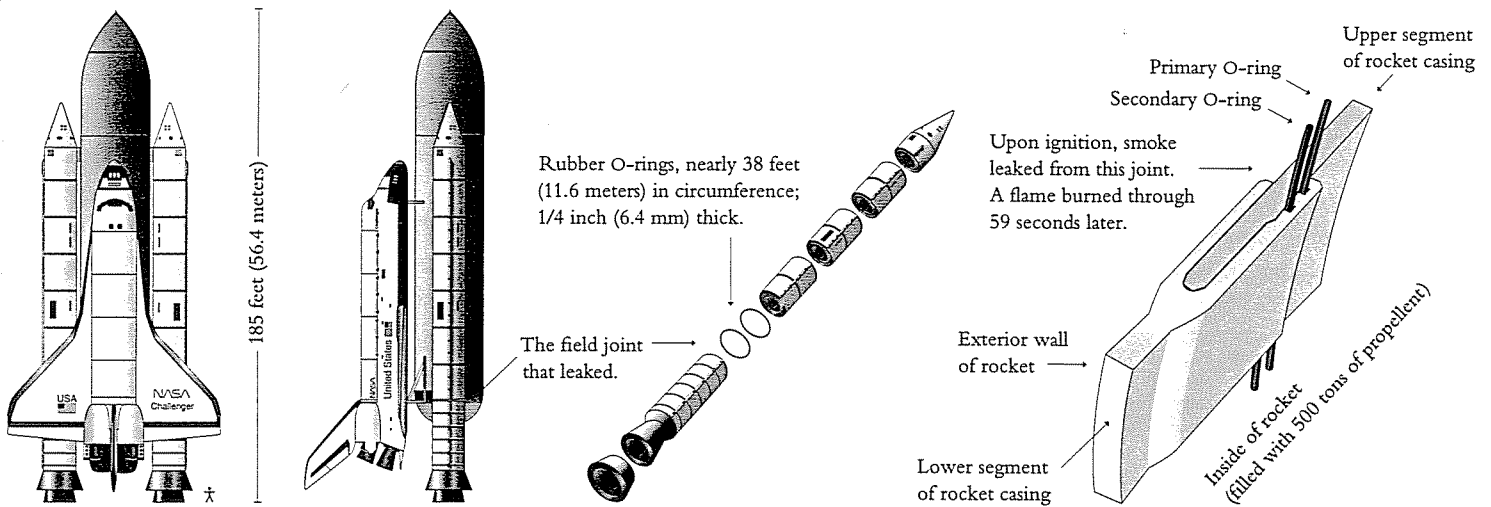
The shuttle consists of an *orbiter* (which carries the crew and has powerful engines in the back), a large liquid-fuel *tank* for the orbiter engines, and 2 solid-fuel *booster rockets* mounted on the sides of the central tank. Segments of the booster rockets are shipped to the launch site, where

they are assembled to make the solid-fuel rockets. Where these segments mate, each joint is sealed by two rubber O-rings as shown above. In the case of the Challenger accident, one of these joints leaked, and a torch-like flame burned through the side of the booster rocket.

THE immediate cause of the accident—an O-ring failure—was quickly obvious (see the photographs at left). But what are the general causes, the lessons of the accident? And what is the meaning of Challenger? Here we encounter diverse and divergent interpretations, as the facts of the accident are reworked into moral narratives.²⁶ These allegories regularly advance claims for the special relevance of a distinct analytic approach or school of thought: if only the engineers and managers had the skills of field X, the argument implies, this terrible thing would not have happened. Or, further, the insights of X identify the deep causes of the failure. Thus, in management schools, the accident serves as a case study for reflections about groupthink, technical decision-making in the face of political pressure, and bureaucratic failures to communicate. For the authors of engineering textbooks and for the physicist Richard Feynman, the Challenger accident simply confirmed what they already

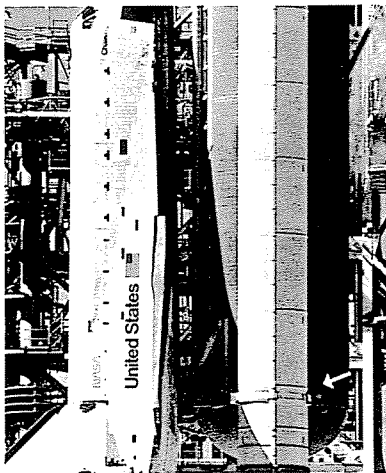
Less than 1 second after ignition, a puff of smoke appeared at the aft joint of the right booster, indicating that the O-rings burned through and failed to seal. At this point, all was lost.

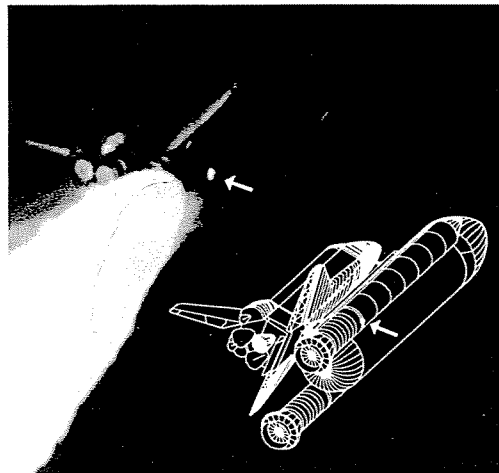
On the launch pad, the leak lasted only about 2 seconds and then apparently was plugged by putty and insulation as the shuttle rose, flying through rather strong cross-winds. Then 58.788 seconds after ignition, when the Challenger was 6 miles up, a flicker of flame emerged from the leaky joint. Within seconds, the flame grew and engulfed the fuel tank (containing liquid hydrogen and liquid oxygen). That tank ruptured and exploded, destroying the shuttle.

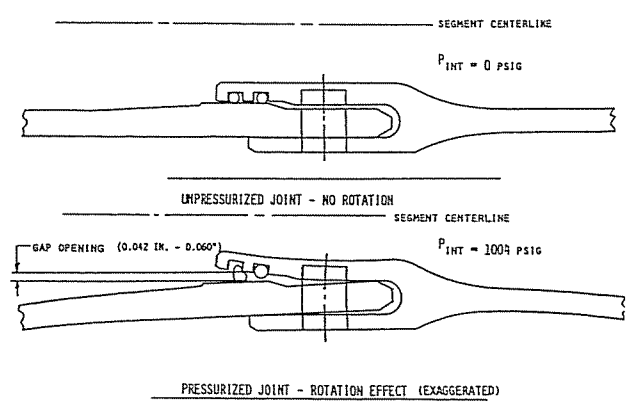
The next chart (below left) describes how erosion in the primary O-ring interacts with its back-up, the secondary O-ring. Then two drawings (below right) make an effective visual comparison to show how rotation of the field joint degrades the O-ring seal. This vital effect, however, is not linked to the potential cause; indeed, neither chart appraises the phenomena described in relation to temperature.

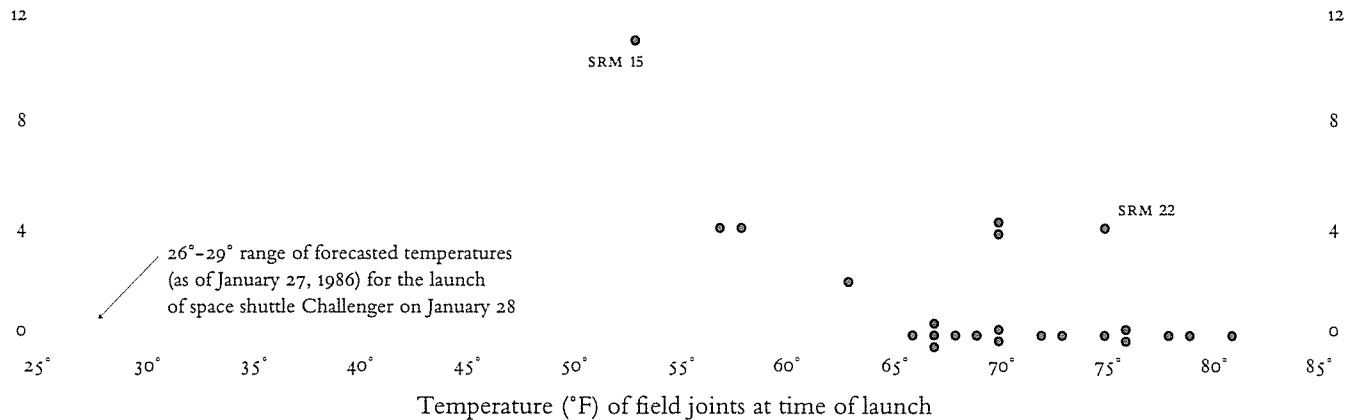
O-ring damage
index, each launch

Above, a scatterplot shows the experience of all 24 launches prior to the Challenger. Like the table, the graph reveals the serious risks of a launch at 29°. Over the years, the O-rings had persistent problems at cooler temperatures: indeed, *every* launch below 66° resulted in damaged O-rings; on warmer days, only a few flights had erosion. In this graph, the temperature scale extends down to 29°, visually expressing the stupendous extrapolation beyond all previous experience that must be made in order to launch at 29°. The coolest flight without any O-ring damage was at 66°, some 37° warmer than predicted for the Challenger; the forecast of 29° is 5.7 standard deviations distant from the average temperature for previous launches. This launch was completely outside the engineering database accumulated in 24 previous flights.

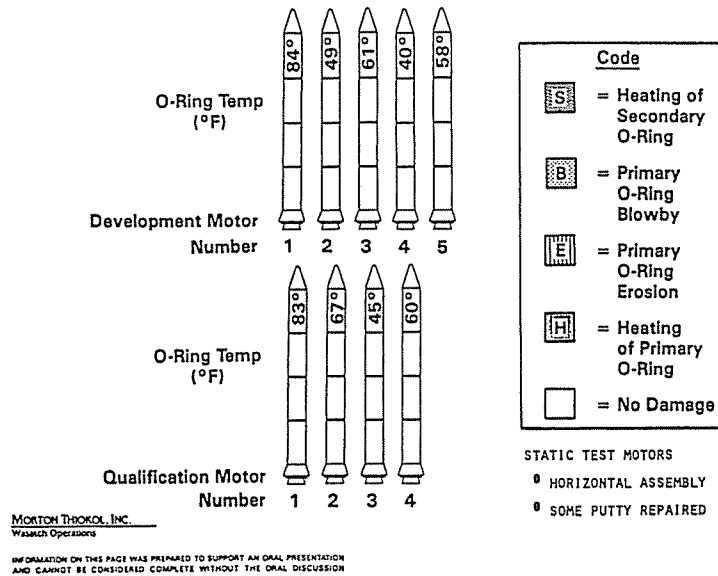
History of O-Ring Damage in Field Joints

Prepared for testimony to the commission, the chart above shows nine little rockets annotated with temperature readings turned sideways. A legend shows a damage scale. Apparently measured in orderly steps, this scale starts with the most serious problem ("Heating of Secondary O-ring," which means a primary ring burned through and leaked) and then continues in several ordered steps to "No Damage." Regrettably, the scale's visual representation is disordered: the cross-hatching varies erratically from dark, to light, to medium dark, to darker, to lightest—a visual pattern unrelated to the substantive order of the measured scale. A letter-code accompanies the cross-hatching. Such codes can hinder visual understanding.

At any rate, these nine rockets suffered no damage, even at quite cool temperatures. But the graph is not on point, for it is based on test data from "Development and Qualification Motors"—all fixed rockets ignited on horizontal test stands at Thiokol, never undergoing the stress of a real flight. Thus this evidence, although perhaps better than nothing (that's all it is better than), is not directly relevant to evaluating the dangers of a cold-weather launch. Some of these same temperature numbers for test rockets are found in a pre-launch chart that we saw earlier.

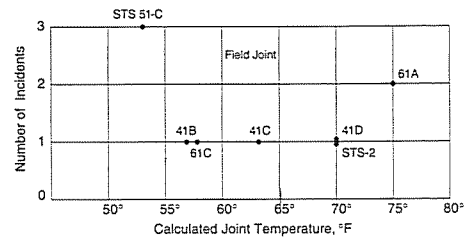
³⁹ Most accounts of the Challenger re-produce a scatterplot that apparently demonstrates the analytical failure of the pre-launch debate. This graph depicts only launches with O-ring damage and their temperatures, omitting all damage-free launches (an absence of data points on the line of zero incidents of damage):

First published in the shuttle commission report (PCSSCA, volume i, p. 146), the chart is a favorite of statistics teachers. It appears in textbooks on engineering, graphics, and statistics—relying on Dalal, Fowlkes, Hoadley, "Risk Analysis of the Space Shuttle: Pre-Challenger Prediction of Failure," who describe the scatterplot as having a central role in the launch decision. (The commission report does not say when the plot was made.) The graph of the missing data-points is a vivid and poignant object lesson in how not to look at data when making an important decision. But it is too good to be true! First, the graph was *not* part of the pre-launch debate; it was *not* among the 13 charts used by Thiokol and NASA in deciding to launch. Rather, it was drawn *after* the accident by two staff members (the executive director and a lawyer) at the commission *as their simulation* of the poor reasoning in the pre-launch debate. Second, the graph implies that the pre-launch analysis examined 7 launches at 7 temperatures with 7 damage measurements. That is not true; only 2 cases of blow-by and 2 temperatures were linked up. The actual pre-launch analysis was much thinner than indicated by the commission scatterplot. Third, the damage scale is dequantified, only counting the number of incidents rather than measuring their severity. In short, whether for teaching statistics or for seeking to understand the practice of data graphics, why use an inaccurately simulated post-launch chart when we have the genuine 13 pre-launch decision charts right in hand? (On this scatterplot, see Lighthall, "Launching the Space Shuttle Challenger;" and Vaughan, *Challenger Launch Decision*, pp. 382-384.)

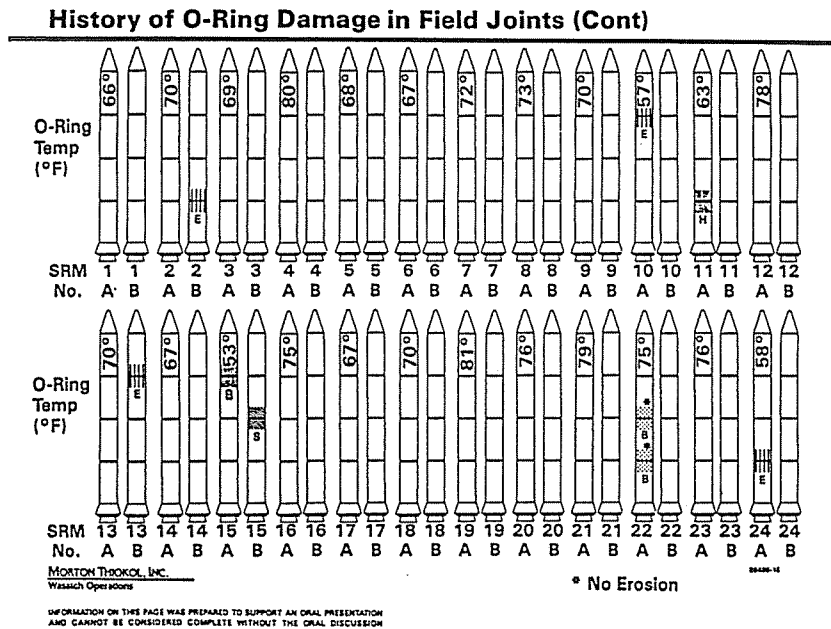
The second chart in the sequence is most significant. Shown below are the O-ring experiences of all 24 previous shuttle launches, with 48 little rockets representing the 24 flight-pairs:

Rockets marked with the damage code show the seven flights with O-ring problems. Launch temperature is given for each pair of rockets. Like the data matrix we saw earlier, this display contains *all* the information necessary to diagnose the relationship between temperature and damage, if we could only see it.⁴¹ The poor design makes it impossible to learn what was going on. In particular:

The Disappearing Legend At the hearings, these charts were presented by means of the dreaded overhead projector, which shows one image after another like a slide projector, making it difficult to compare and link images. When the first chart (the nine little rockets) goes away, the visual code calibrating O-ring damage also vanishes. Thus viewers need to memorize the code in order to assess the severity and type of damage sustained by each rocket in the 48-rocket chart.

⁴¹ This chart shows the rocket pair SRM 4A, SRM 4B at 80°F, as having *undamaged* O-rings. In fact, those rocket casings were lost at sea and their O-ring history is unknown.

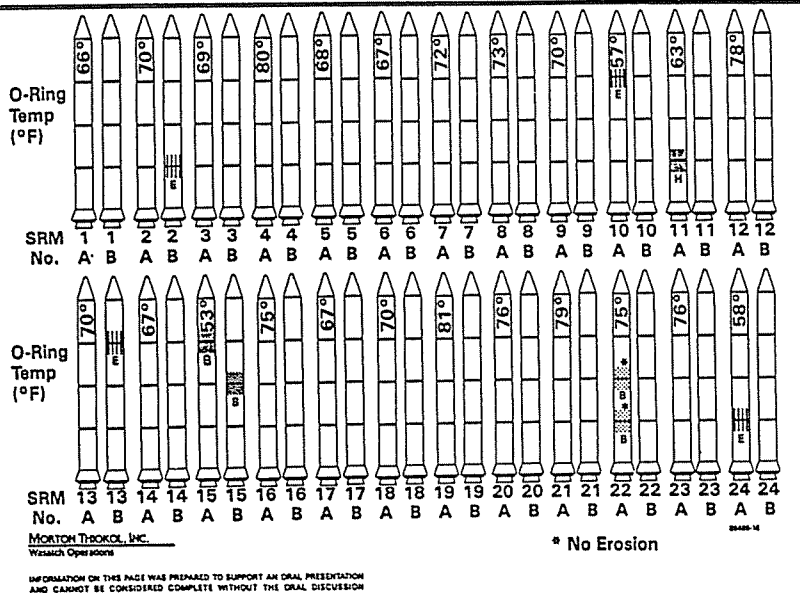
History of O-Ring Damage in Field Joints (Cont)

Chartjunk Good design brings *absolute attention* to data. Yet instead of focusing on a possible link between damage and temperature—the vital issue here—the strongest visual presence in this graph is the clutter generated by the outlines of the 48 little rockets. The visual elements bounce and glow, as heavy lines activate the white space, producing visual noise. Such misplaced priorities in the design of graphs and charts should make us suspicious about the competence and integrity of the analysis. Chartjunk indicates statistical stupidity, just as weak writing often reflects weak thought: “Neither can his mind be thought to be in tune, whose words do jarre,” wrote Ben Jonson in the early 1600s, “nor his reason in frame, whose sentence is preposterous.”⁴²

Lack of Clarity in Depicting Cause and Effect Turning the temperature numbers sideways obscures the causal variable. Sloppy typography also impedes inspection of these data, as numbers brush up against line-art. Likewise garbled is the measure of effect: O-ring anomalies are depicted by little marks—scattered and opaquely encoded—rather than being totaled up into a summary score of damage for each flight. Once again Jonson’s Principle: these problems are more than just poor design, for a lack of visual clarity in arranging evidence is a sign of a lack of intellectual clarity in reasoning about evidence.

Wrong Order The fatal flaw is the *ordering* of the data. Shown as a time-series, the rockets are sequenced by date of launching—from the first pair at upper left SRM 1 1 to the last pair at lower right 24 24 (the launch immediately prior to Challenger). The sequential order conceals the possible link between temperature and O-ring damage, thereby throwing statistical thinking into disarray. The time-series

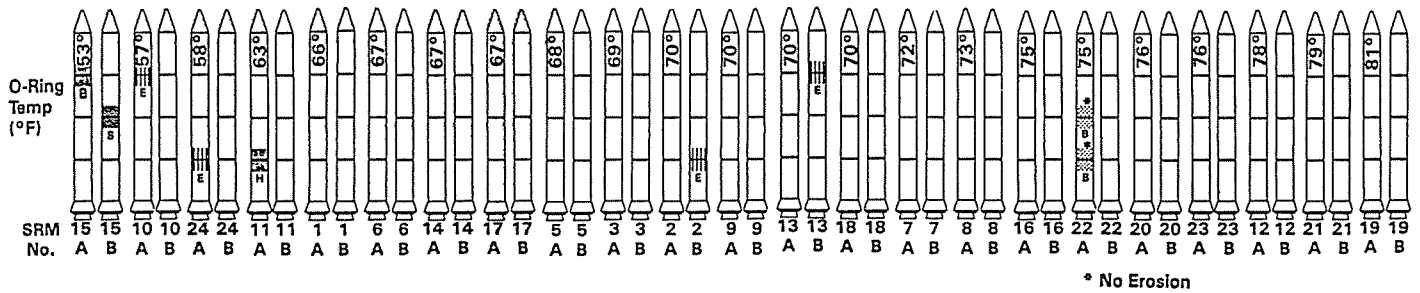
chart at left bears on the issue: Is there a time trend in O-ring damage? This is a perfectly reasonable question, but not the one on which the survival of Challenger depended. That issue was: Is there a temperature trend in O-ring damage?

Information displays should serve the analytic purpose at hand; if the substantive matter is a possible cause-effect relationship, then graphs should organize data so as to illuminate such a link. Not a complicated idea, but a profound one. Thus the little rockets must be placed in order by temperature, the possible cause. Above, the rockets are so ordered by temperature. This clearly shows the serious risks of a cold launch, for most O-ring damage occurs at cooler temperatures. Given this evidence, how could the Challenger be launched at 29°?

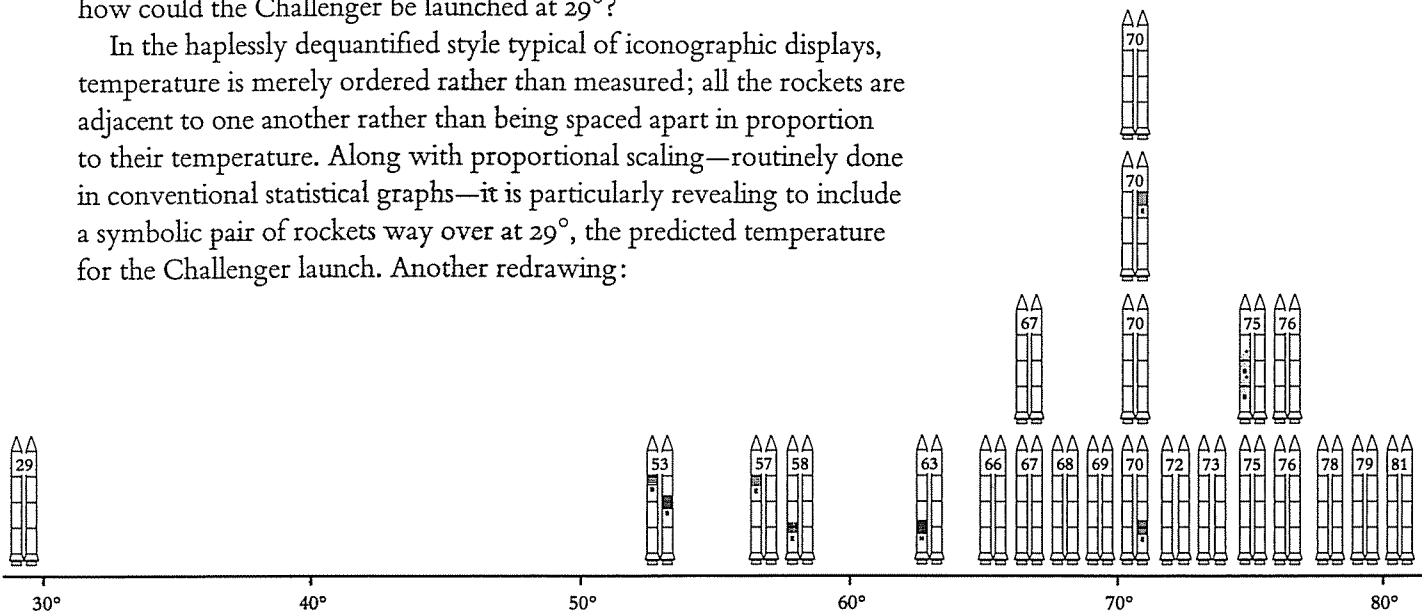
In the haplessly dequantified style typical of iconographic displays, temperature is merely ordered rather than measured; all the rockets are adjacent to one another rather than being spaced apart in proportion to their temperature. Along with proportional scaling—routinely done in conventional statistical graphs—it is particularly revealing to include a symbolic pair of rockets way over at 29°, the predicted temperature for the Challenger launch. Another redrawing:

Even after repairs, the pictorial approach with cute little rockets remains ludicrous and corrupt. The excessively original artwork just plays around with the information. It is best to forget about designs involving such icons and symbols—in this case and, for that matter, in nearly all other cases. These data require only a simple scatterplot or an ordered table to reveal the deadly relationship.

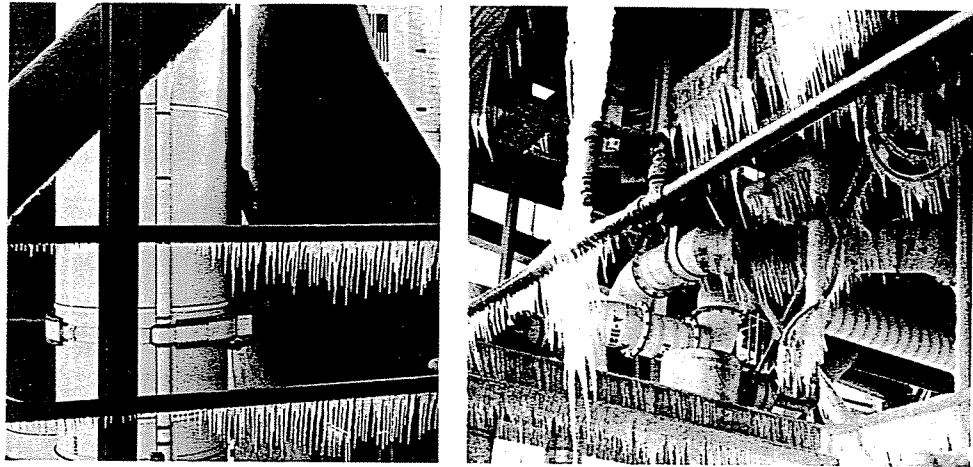
To create a more effective exhibit, the clamped O-ring might well have been placed in a transparent glass of ice water rather than in the opaque cup provided to Feynman. Such a display would then make a visual reference to the extraordinary pre-flight photographs of an ice-covered launch pad, thereby tightening up the link between the ice-water experiment and the Challenger.⁴⁵

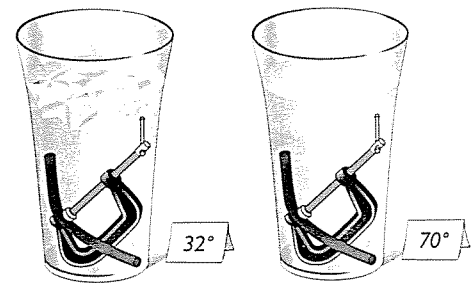
A controlled experiment would not merely evoke the well-known empirical connection between temperature and resiliency, but would also reveal the overriding *intellectual* failure of the pre-launch analysis of the evidence. That failure was a lack of control, a lack of comparison.⁴⁸ The 13 pre-launch charts, like the one-glass experiment, examine only a few instances of O-ring problems and not the causes of O-ring success. A sound demonstration would exemplify the idea that in reasoning about causality, *variations in the cause* must be explicitly and measurably linked to *variations in the effect*. These principles were violated in the 13 pre-launch charts as well as in the post-launch display that arranged the 48 little rockets in temporal rather than causal order. Few lessons about the use of evidence for making decisions are more important: story-telling, weak analogies, selective reporting, warped displays, and anecdotes are not enough.⁴⁹ Reliable knowledge grows from evidence that is collected, analyzed, and displayed with some good comparisons in view. And why should we fail to be rigorous about evidence and its presentation just because the evidence is a part of a public dialogue, or is meant for the news media, or is about an important problem, or is part of making a critical decision in a hurry and under pressure?

⁴⁸ Feynman was aware of the problematic experimental design. During hearings in the afternoon following the ice-water demonstration, he began his questioning of NASA management with this comment: "We spoke this morning about the resiliency of the seal, and if the material weren't resilient, it wouldn't work in the appropriate mode, or it would be less satisfactory, in fact, it might not work well. I did a little experiment here, and *this is not the way to do such experiments*, indicating that the stuff looked as if it was less resilient at lower temperatures, in ice." (PCSSCA, volume IV, pp. 739-740, transcript, emphasis added.) Drawing of two-glass experiment by Weilin Wu and Edward Tufte.
